Report No. UT-02.17

***PAVEMENT AND
SUBGRADE DISTRESS –
REMEDIAL STRATEGIES
FOR CONSTRUCTION AND
MAINTENANCE (I-15
Mileposts 200-217)***

**By: Kyle M. Rollins, Ph.D
Ryan Christie**

**Utah Department of Transportation
Research Division**

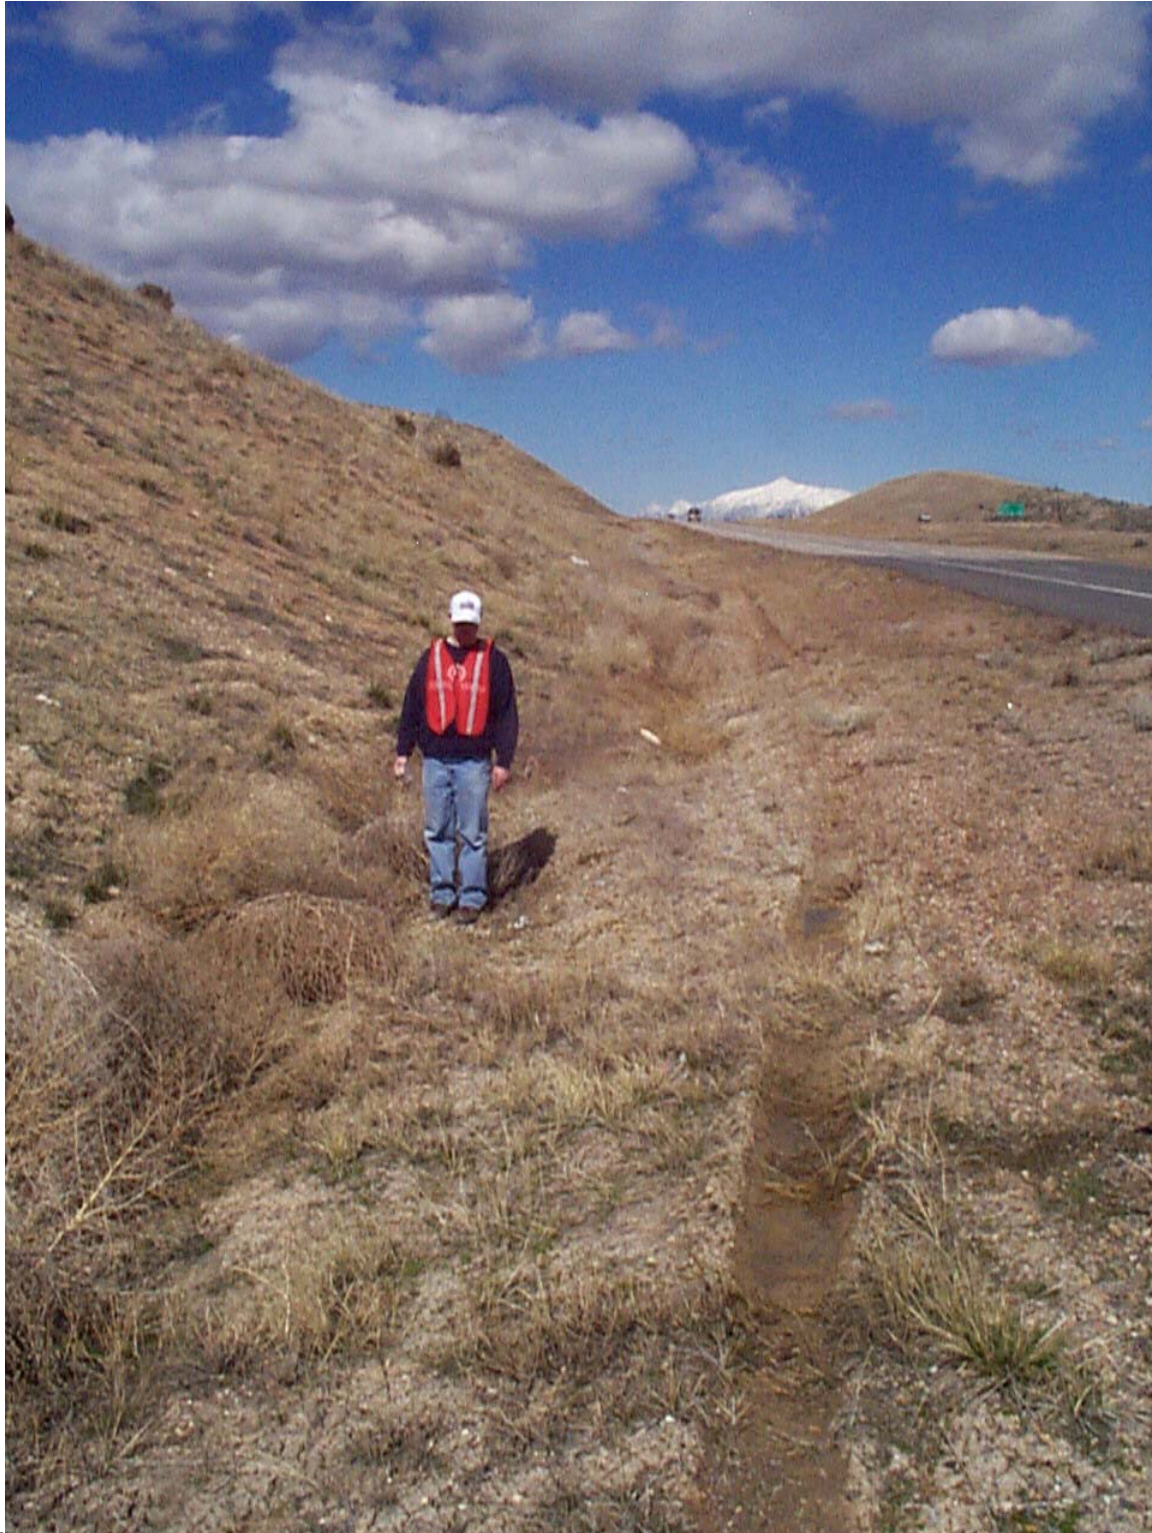
Figure 64: Plant-filled drainage on the western side of the southbound lane of I-15 near Drill Hole 6. The ground is very soft due to ponding of water and percolation into the subgrade.

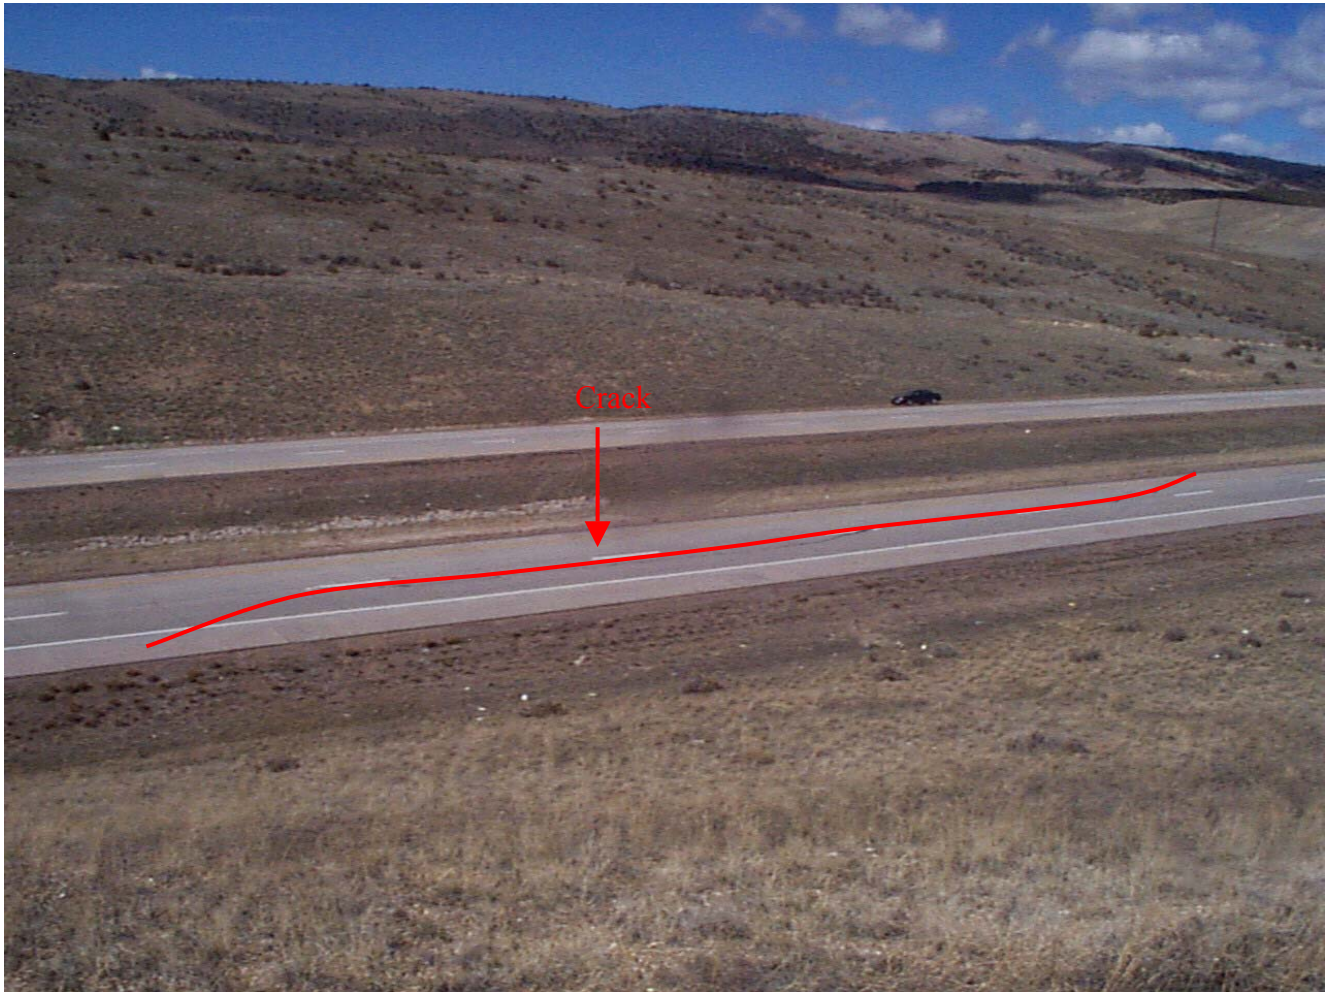
Figure 65: Looking northwest at the area around Drill Holes 7 and 8. Drill Hole 7 was drilled through the west fill bank of the northbound lanes of I-15. Drill Hole 8 was drilled through the east cut section east of the northbound lanes of I-15. (Large longitudinal crack extending from the right side of the picture to the left side of the picture is shown in red.)

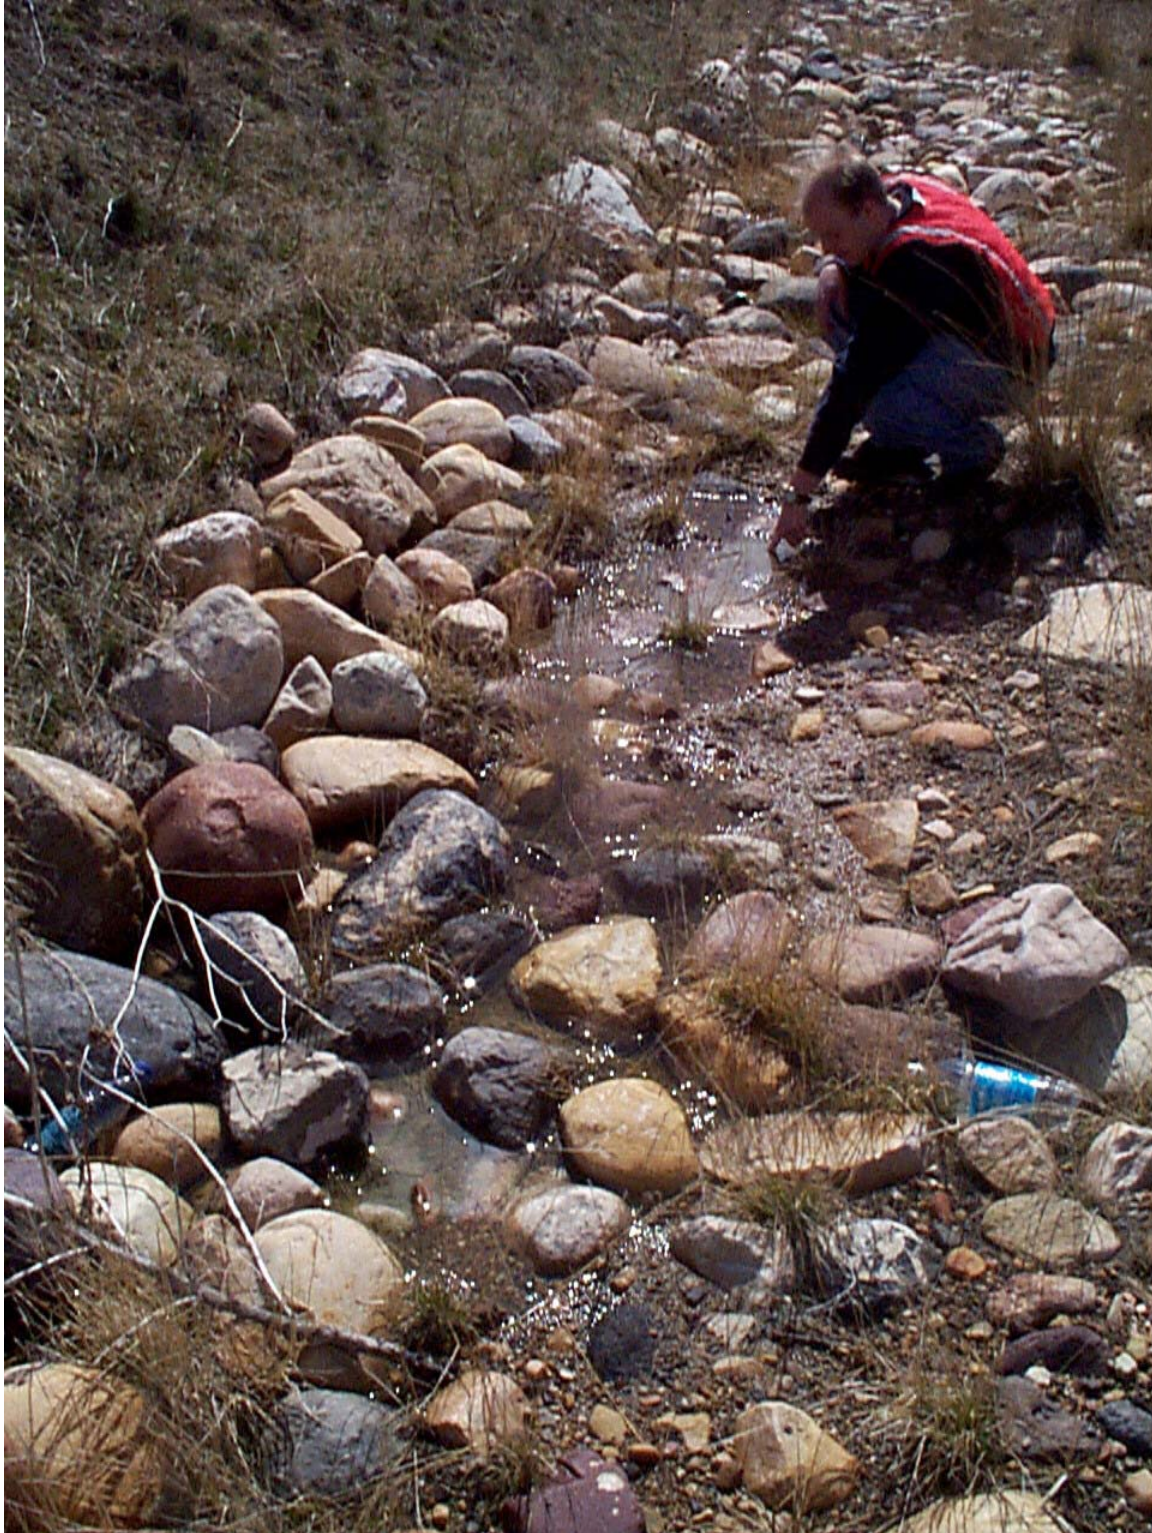
Figure 69: Water ponding in drainage ditch along the east cut section of I-15 near Drill Holes 7 and 8.

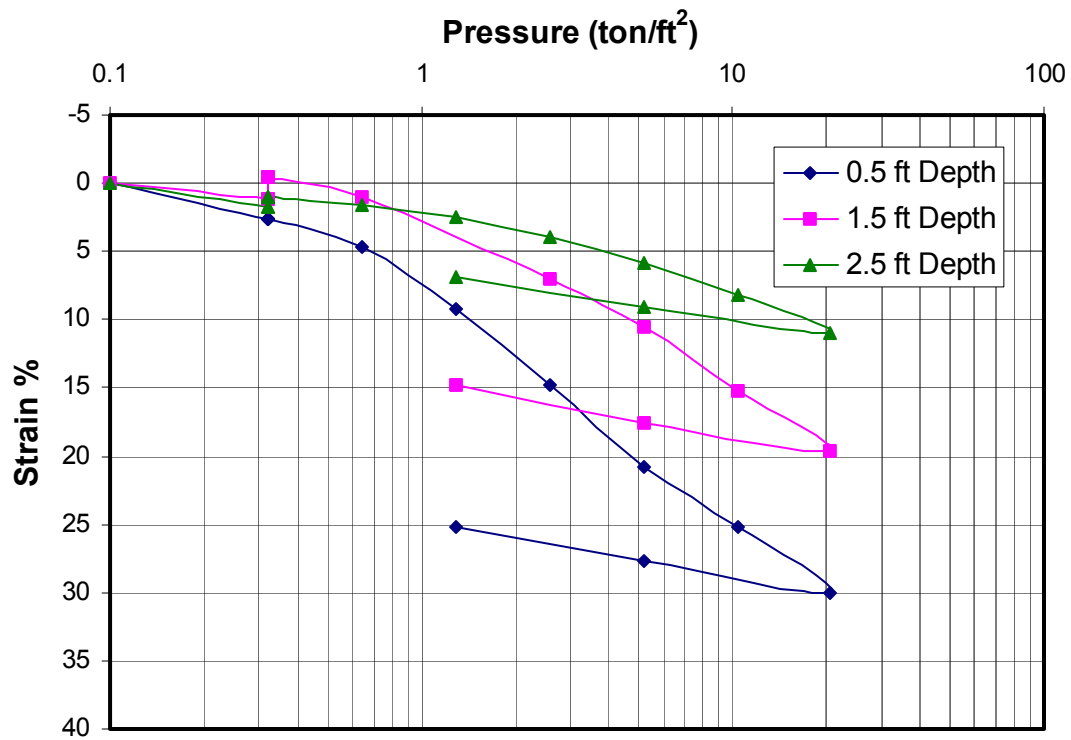
The measured strain versus applied pressure curves from consolidation tests on samples from Drill Hole 6 are shown in Figure 70. The samples were initially loaded at the natural moisture content and then water was added to saturate the samples when the pressure reached the overburden pressure. The percent swell as a function of depth is shown in Figure 71. The maximum swell percentage following wetting was only 1.5 %; however, it should be recognized that the natural moisture content of the samples was relatively high prior to testing. Substantial swell likely would have already occurred prior to the laboratory testing.

Figure 70: Strain versus applied pressure curves from consolidation tests performed on three samples from Drill Hole 6.

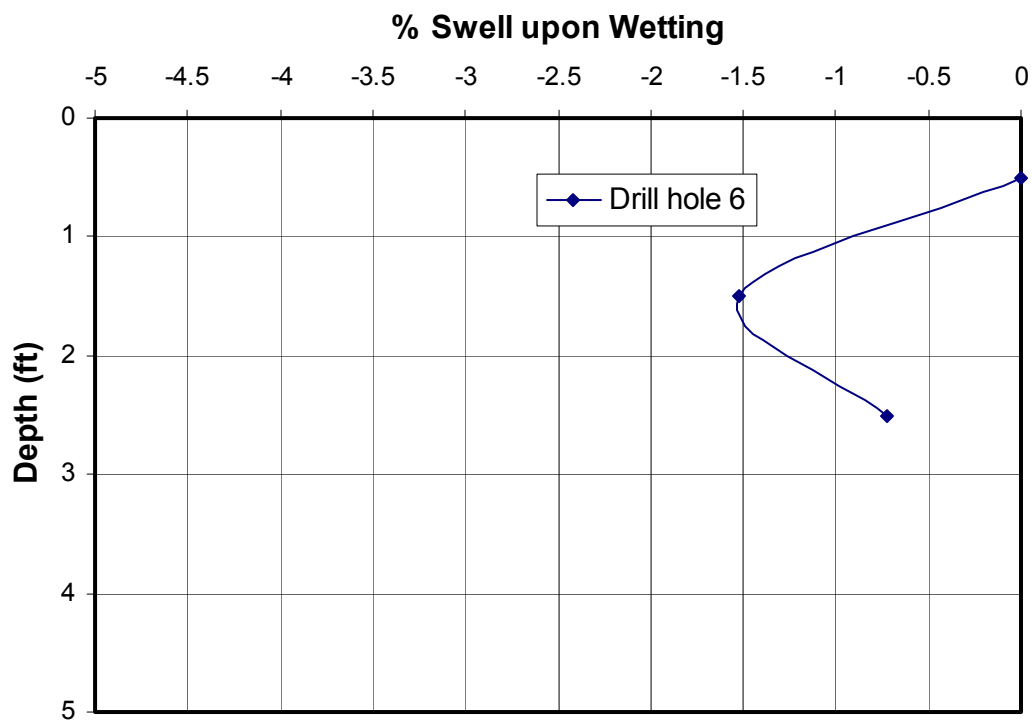
Figure 71: Percent swell (in negative numbers) upon wetting versus depth for samples from Drill Hole 6.

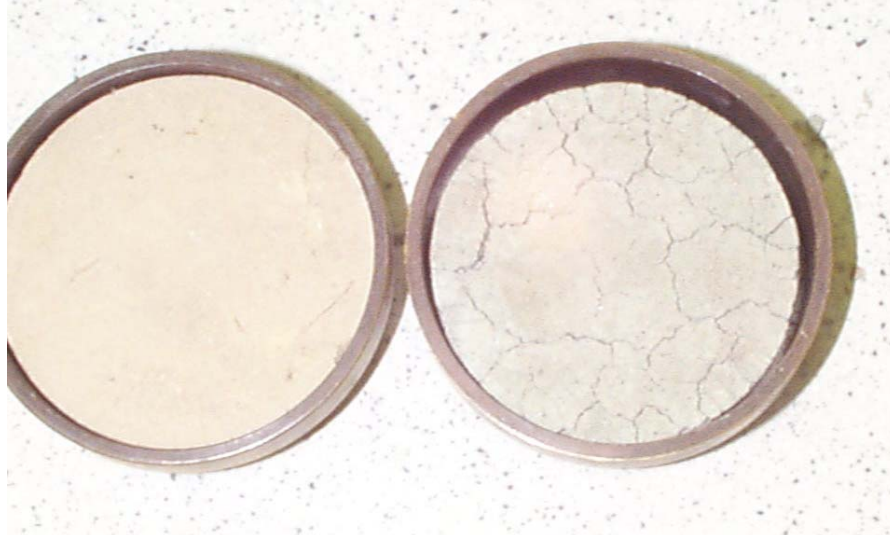
Perhaps a better indication of the change in volume due to moisture fluctuation is provided by the shrinkage observed when the samples were dried subsequent to testing. For example the specimens from Drill Hole 6 experienced a volumetric strain of 15 to 25 % due to drying. This shrinkage due to drying is illustrated in Figure 72 where the test rings are shown along with the soil specimens following drying. The soil specimens initially had the same diameter as the steel ring. A sample of collapsible soil with a low plasticity index has a diameter following drying which is slightly smaller than the test ring; however, the sample of expansive soil has a diameter which is much smaller than the test ring due to shrinkage. A close-up view of the dried expansive soil sample relative to the test ring is shown in Figure 73. This potential for shrinkage and swelling when the water content fluctuates with the seasons can lead to cracking and differential movement of a pavement structure. This process will continue unabated over time unless the expansive soil is removed or treated.

Figure 72: Shrinkage of expansive soil specimen from Drill Hole 6 (on right) after drying compared with that for collapsible soil specimen from Drill Hole 5 (on left). Both soil specimens initially had the same diameter as the steel ring.

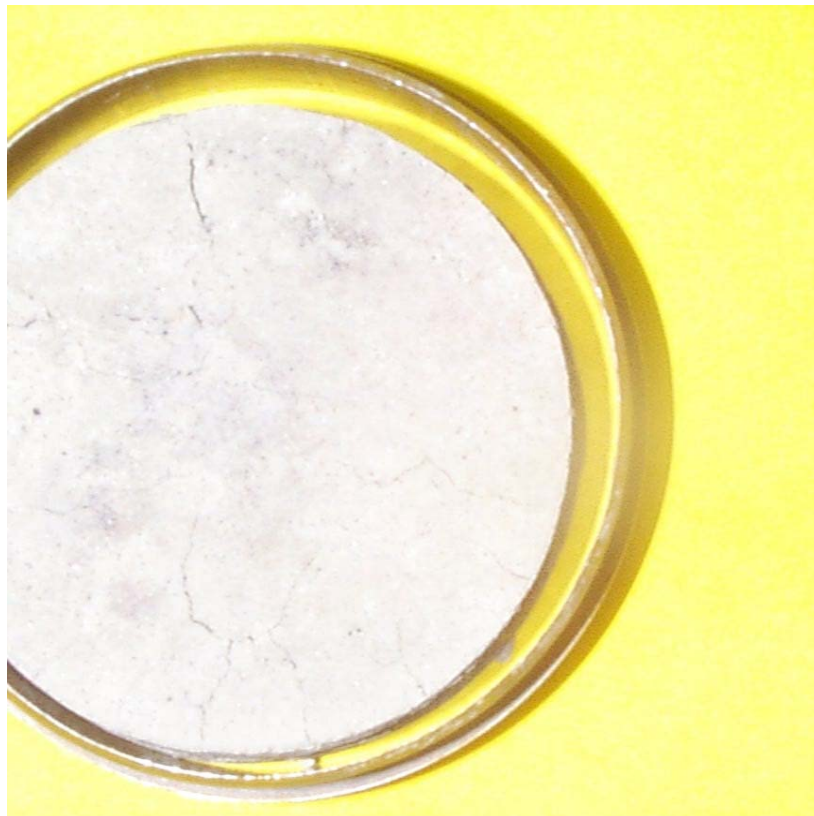
Figure 73: A close-up view of consolidation test specimen from Drill Hole 6 showing the change in diameter of the sample due to drying. The specimen fit tightly into the ring before drying.

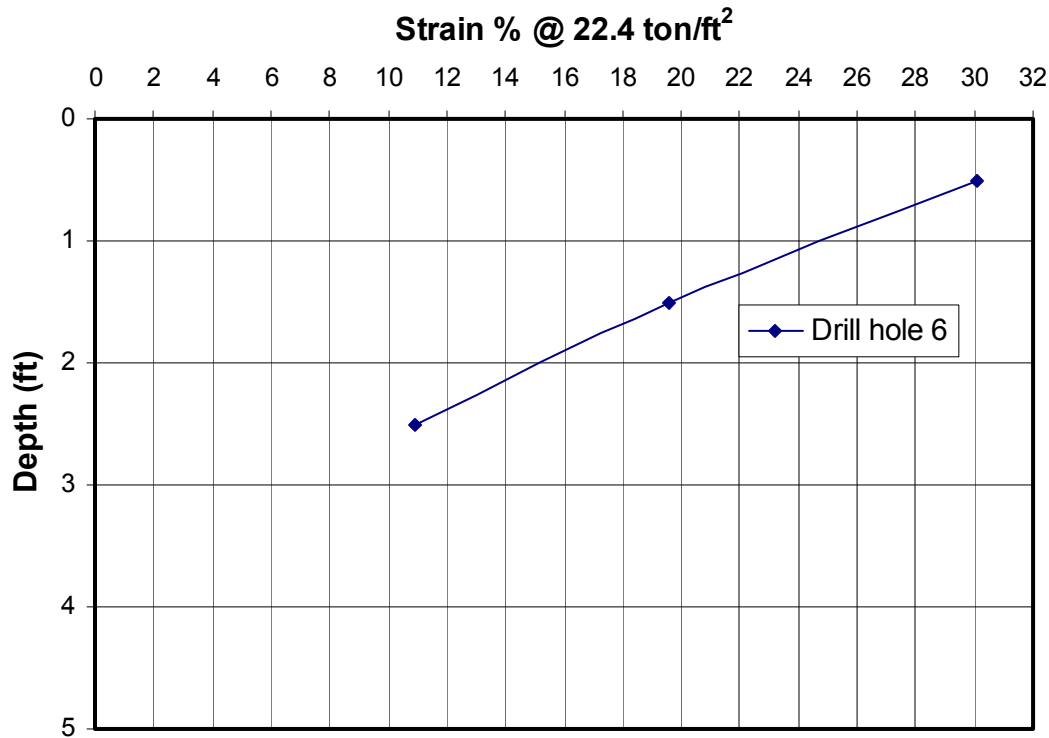
Figure 74: Percent strain versus depth at an overburden pressure of 22.4 tons/ft² for samples from Drill Hole 6.

Figure 74 shows the measured strain versus depth in Drill Hole 6 for an applied pressure of 22.4 tons/ft². Although this pressure is significantly higher than the pressure currently existing on the specimens, it does illustrate that the stiffness of the soil does increase substantially with depth. This is likely due to the fact that weathering is more pronounced at the ground surface and decreases with depth.

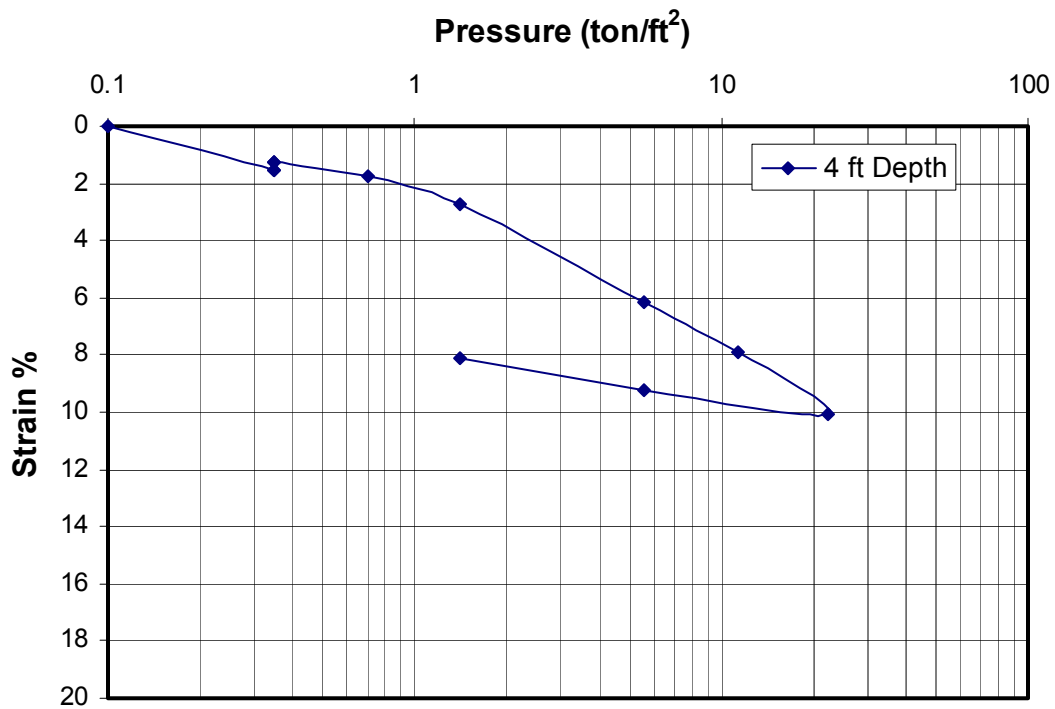
Figures 75 and 76 present the strain versus applied pressure curves obtained from consolidation tests on samples from Drill Holes 7 and 8, respectively. The sample at 4 foot depth in Drill Hole 7, with a PI of 21, only swelled 0.26 % upon wetting. A test could not be conducted on the sample at 1.5 feet, with a PI of 51, because the sample was very hard and extremely brittle in its dry natural state. The maximum percent swell for Drill Hole 8 was 0.98 % of the initial volume. The maximum percent collapse for Drill Hole 8 was 4.52 % of the initial volume at a depth of one foot.

Figure 75: Strain versus applied pressure curve for test sample from Drill Hole 7.

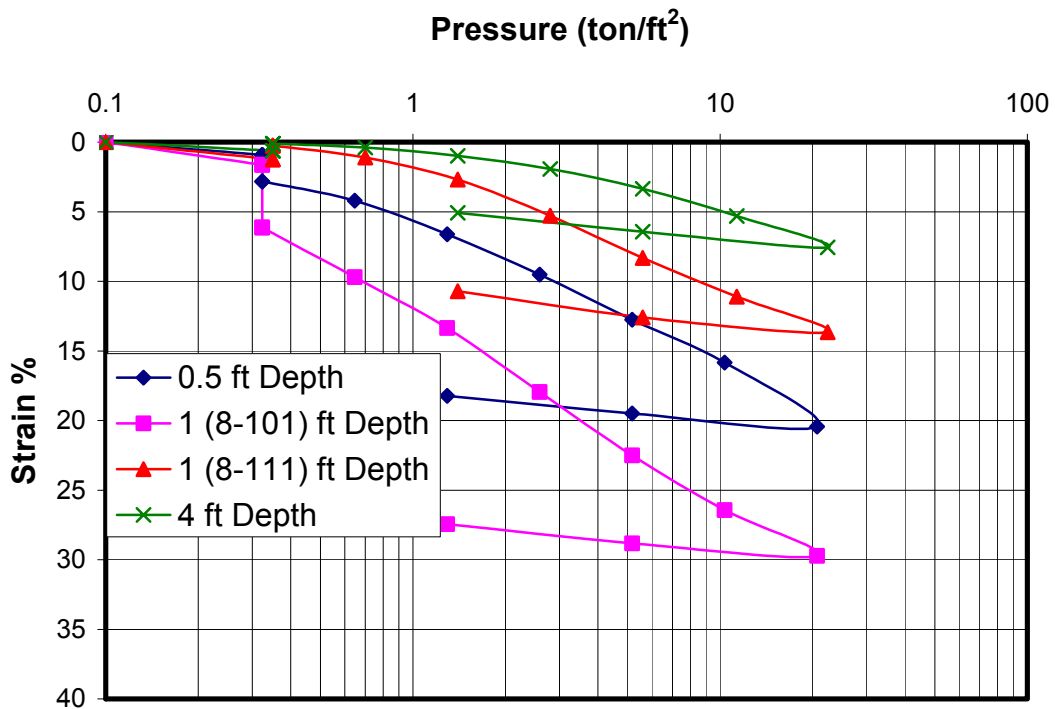
Figure 76: Strain versus applied pressure curves for test samples from Drill Hole 8.

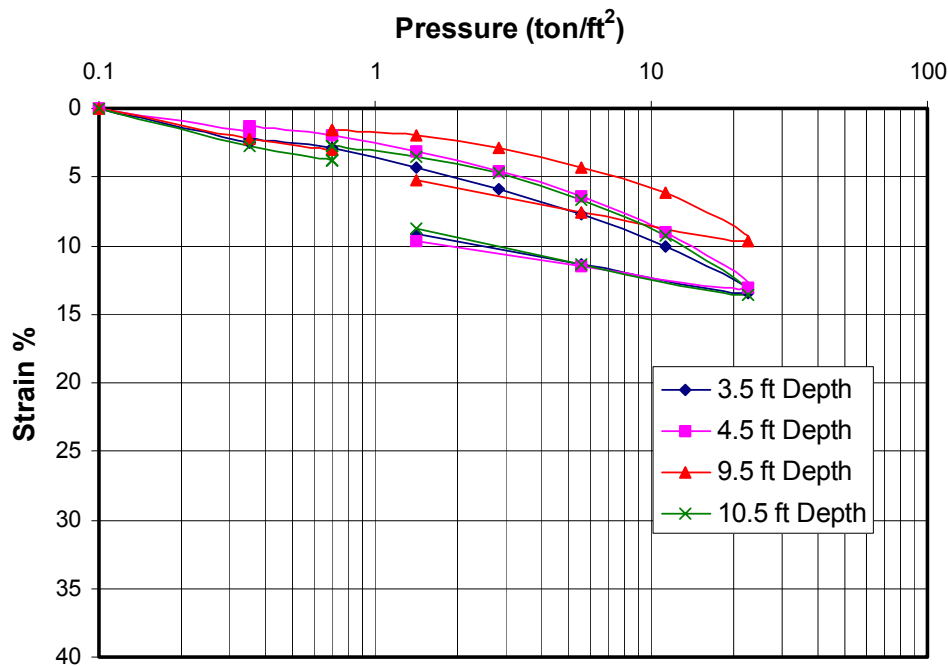
The measured strain as a function of applied pressure for the consolidation tests on samples from Drill Hole 9 are presented in Figure 82. The specimens were initially loaded at their natural moisture content and were subsequently saturated when the applied pressure reached the overburden pressure. Although the specimens had natural moisture contents that were relatively high, the addition of water did produce a small amount of swell. The percent swell as a function of depth below the ground surface based on the tests is shown in Figure 83. The undrained shear strength of the subgrade, measured with the unconfined compression test, is shown as a function of depth in Figure 84.

Figure 82: The percent strain versus applied pressure for samples at 3.5, 4.5, 9.5 and 10.5 foot depths in Drill Hole 9. Water was added to saturate the specimen at the overburden pressure for each sample.

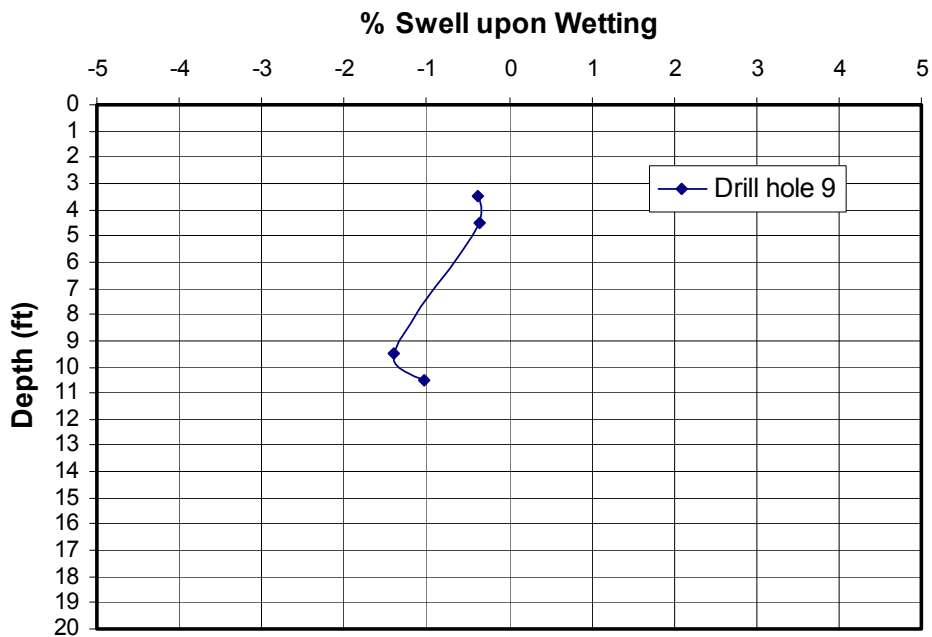
Figure 83: Percent swell (in negative numbers) as a function of depth based on consolidation tests on samples from Drill Hole 9.

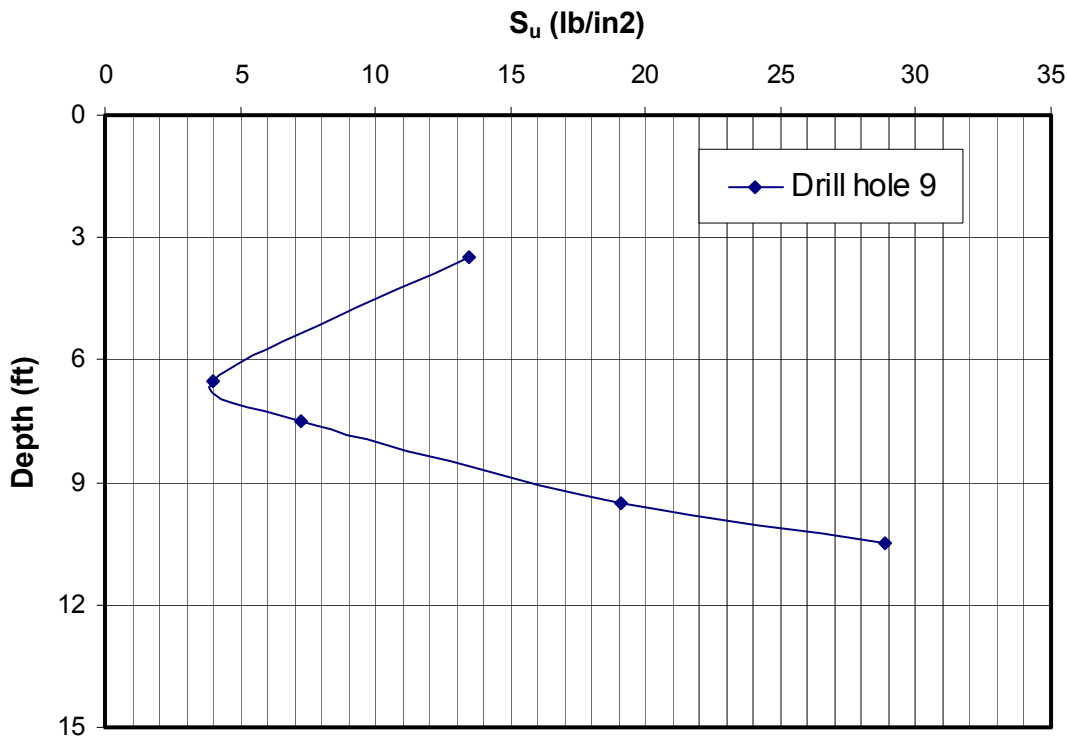
Figure 84: Undrained Shear Strength for test specimens from Drill Hole 9.

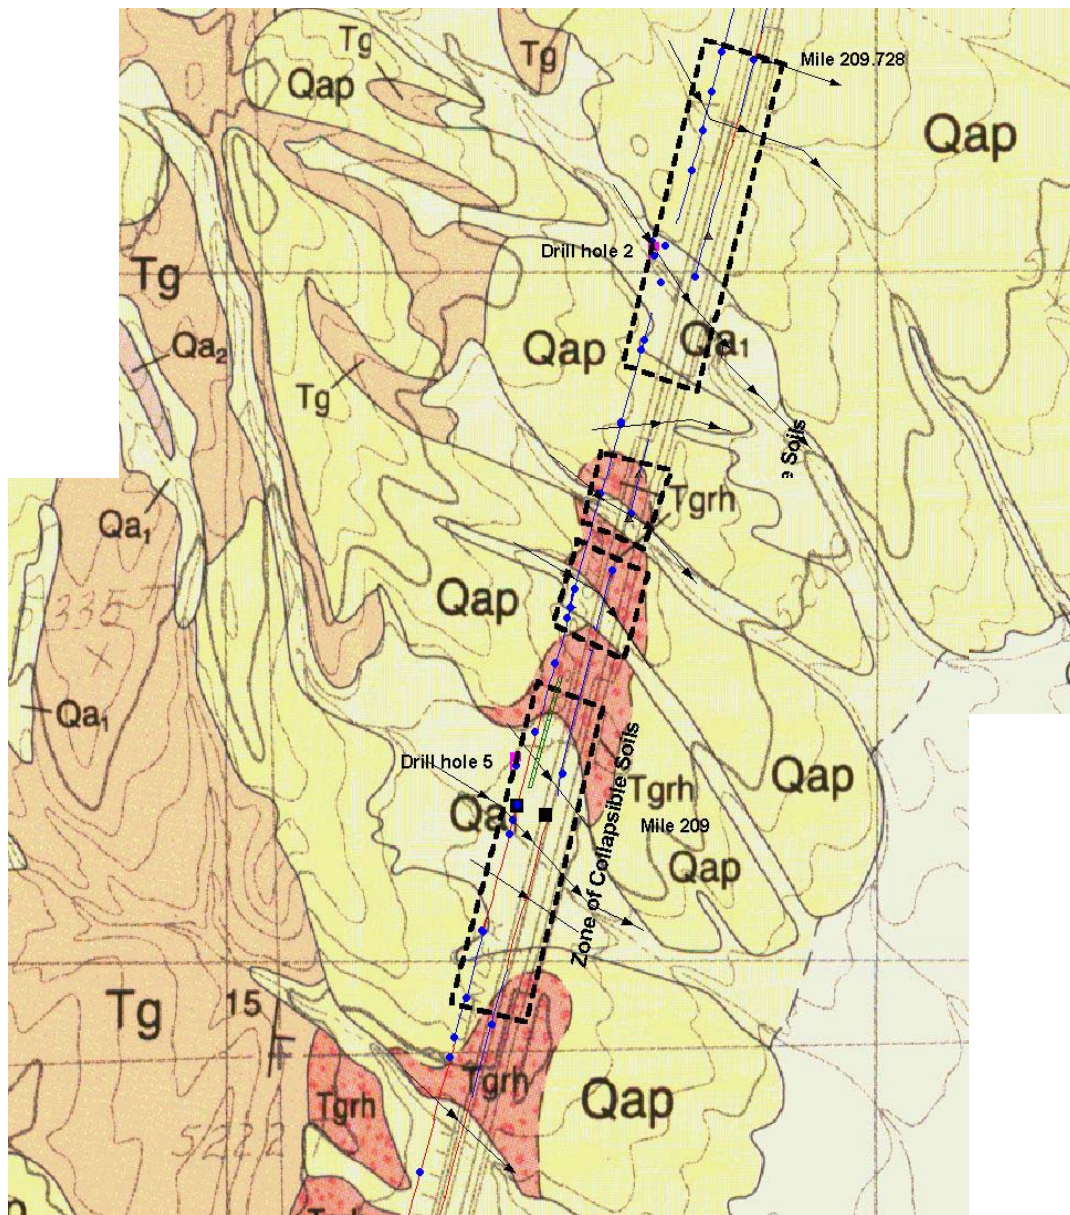
Figure 87: Map showing Drill Hole 2 and the distress features likely related to collapsible soils. The dashed black boxes represent the proposed length of highway for treatment.

Based on the thickness of the collapsible soil identified during this study, we recommend that deep dynamic compaction be used to treat the collapsible soils in the four zones identified previously. In these zones, the current distress has been significant enough that we consider positive soil densification to be appropriate. As indicated previously, laboratory collapse tests demonstrate that despite previous settlement the existing soil profile is still capable of inducing significant collapse settlement from future wetting episodes. DDC is relatively inexpensive considering the improvement that is produced in-situ without the need for significant earth moving. In addition, the performance of highways on collapsible soils treated in this manner has been relatively good (Rollins and Kim, 1994; Rollins et al., 1999).

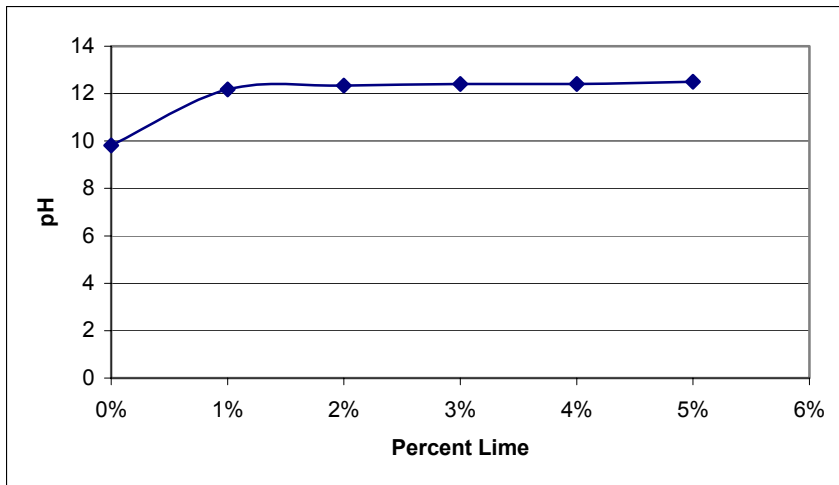
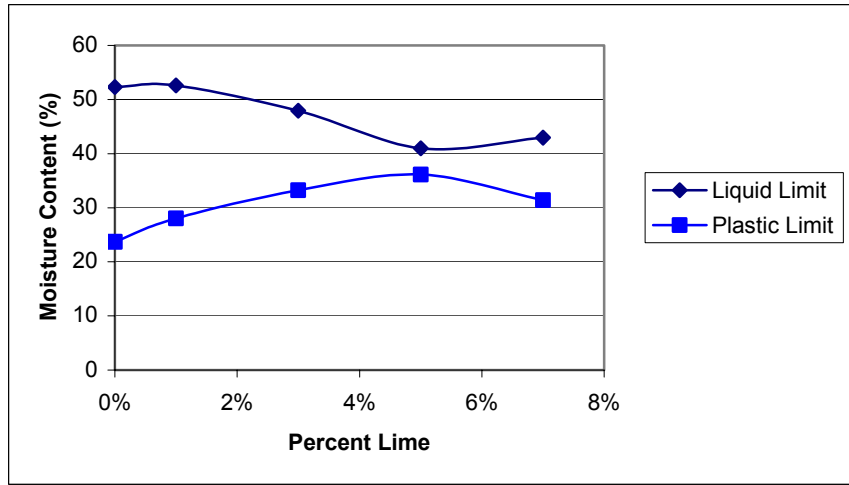
Figure 95: pH and moisture content versus percent lime for sample 2 at 2 ft depth, a brownish gray clay.

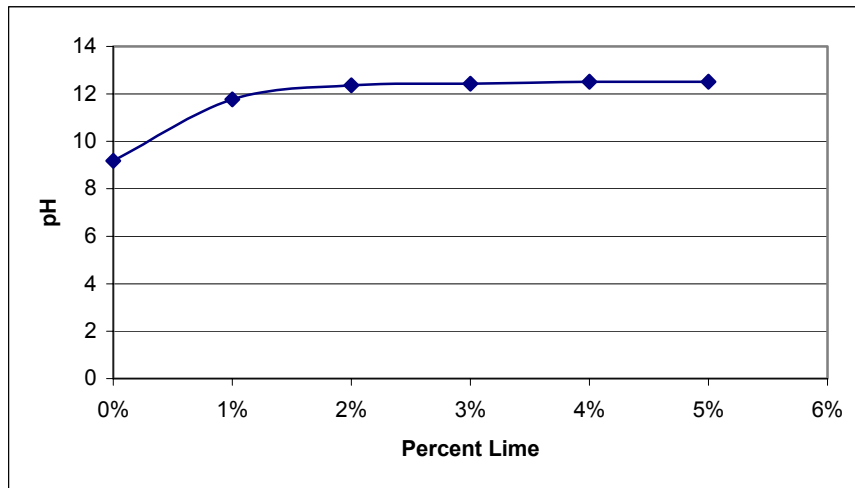
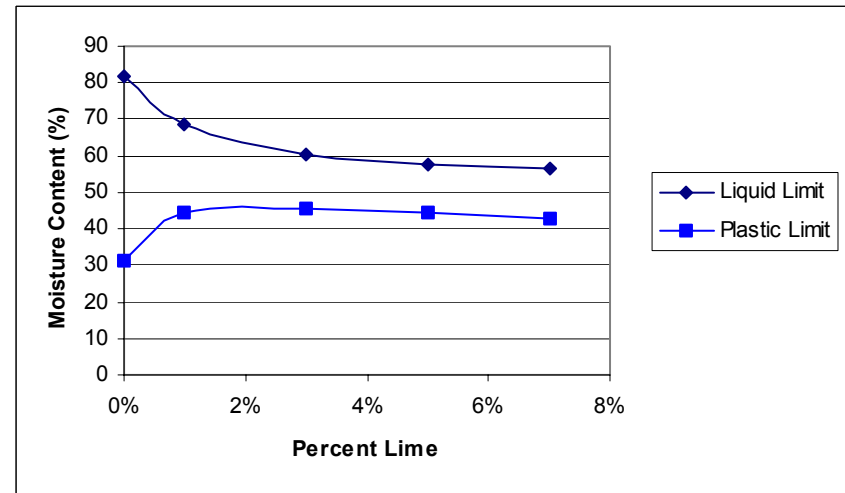
Figure 96: pH and moisture content versus percent lime for sample 6 a 2 ft depth, a green clay.

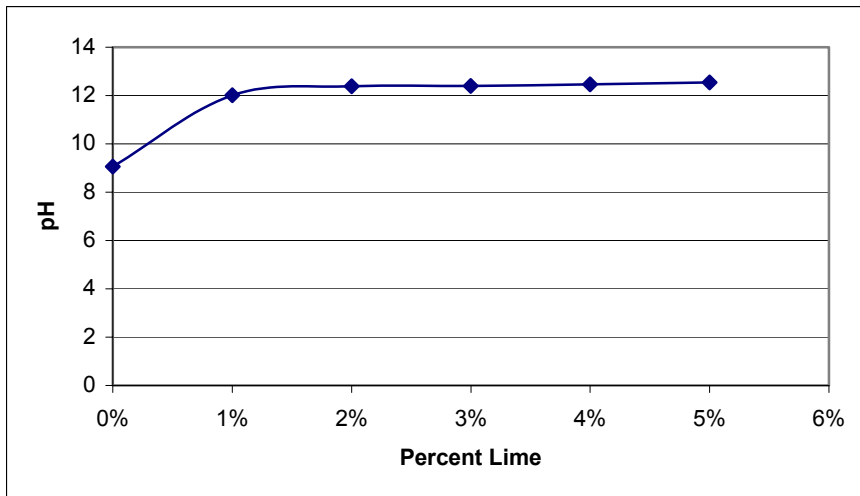
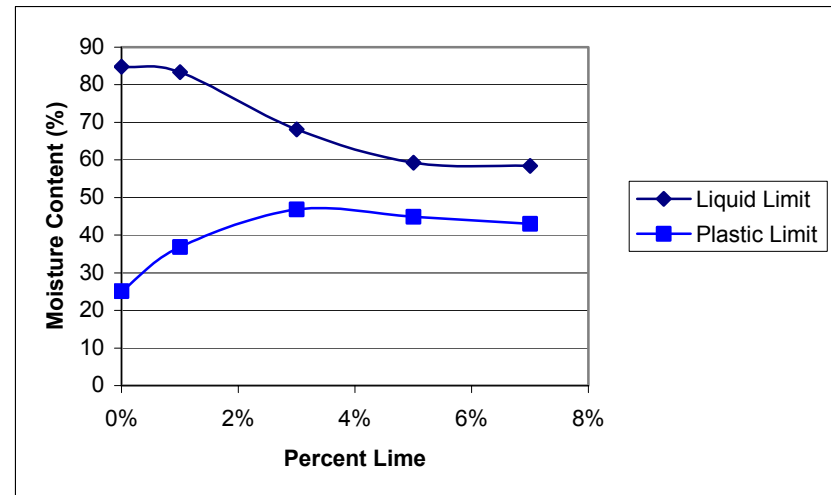
Figure 97: pH and moisture content versus percent lime for sample 13 at 1 ft depth, a green clay.
